# Case Study: City of Aiken Downtown Stormwater

## Sand River Headwaters Green Infrastructure Project – Aiken, South Carolina

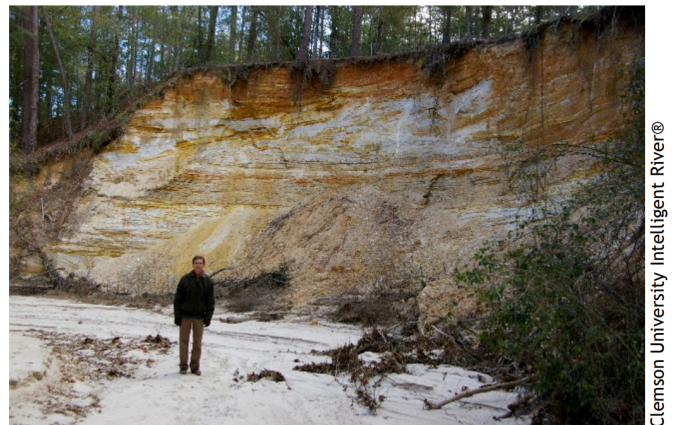
**Exhibit 23.** Stormwater has eroded a deep canyon in the banks of the Sand River.

Conventional Stormwater infrastructure installed in the 1950s and impervious cover directed increasing amounts of high velocity water to a single outfall into the Sand River. This eroded a 70 FT canyon, destabilized banks, filled wetlands, and severely impacted local ecology.
